Manhole Inspection Summary

Manhole # S29YY_043MH

Insp Date: **5/23/07 9:29 AM**

Location Address: **613 HARDING PL**

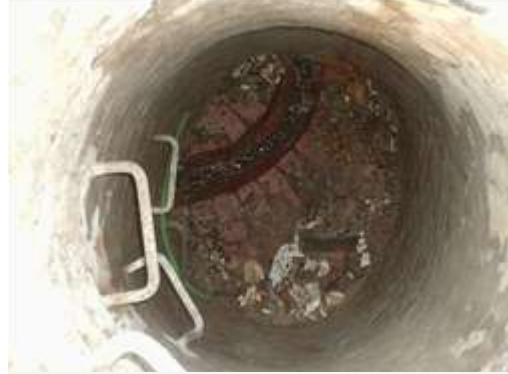
Top View

Evidence of surcharge - Bench debris.
Channel debris.

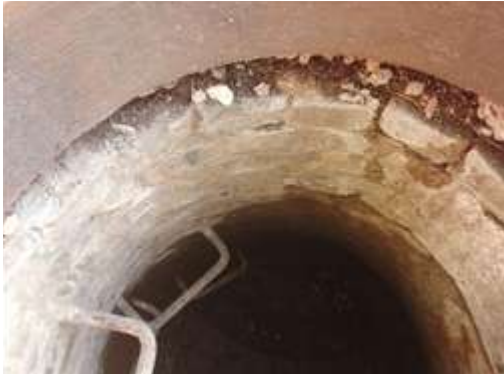
Defect

Frame leaks. Adjustment deterioration,
loose brick and infiltration. Barrel
infiltration - other side.

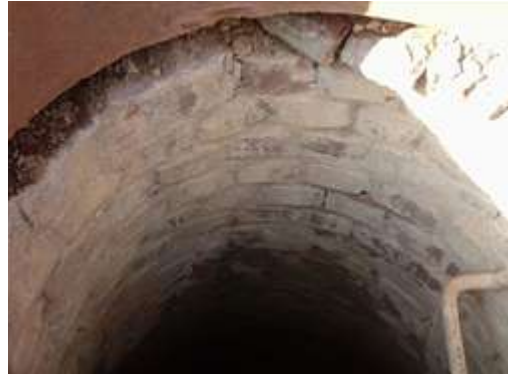
Defect

Frame leaks. Adjustment deterioration,
loose brick and infiltration. Barrel
infiltration.

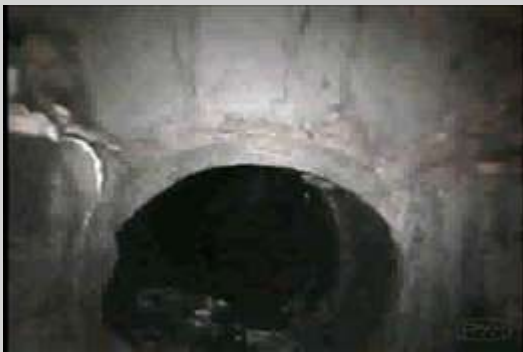
8 in. Circular Gravity Sewer Pipe Out @ 12 O'Clock

Invert Depth: **9.40** (ft.) Flow Characteristics: **Slow**

Deposits: ☐ None ☒ **Mud** ☐ Sludge ☒ **Debris** ☐ Grease

Silt Depth: **0** (in.) Deposits Extent: **Light**

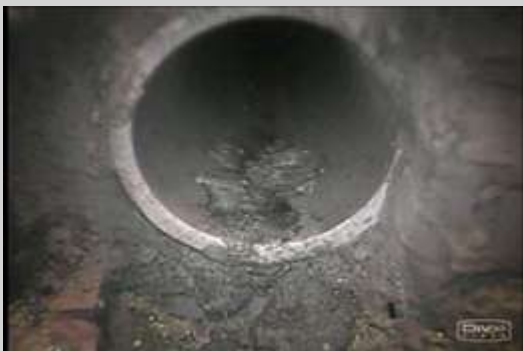
8 in. Circular Gravity Sewer Pipe In @ 9 O'Clock

Invert Depth: **8.32** (ft.) Flow Characteristics: **Slow**

Deposits: ☐ None ☒ **Mud** ☐ Sludge ☒ **Debris** ☐ Grease

Silt Depth: **0** (in.) Deposits Extent: **Light**
